**Flood Control Project Maintenance  
Levee Inspections  
LMA District Cover Sheet  
Spring 2010 Levee Inspection Results**

**Reclamation District No. 0001 Union Island**

**Levee Inspection Report By Mile - Spring 2010**

Waterway				Bank	Unit Miles	Inspection Start/End	Inspector	
Unit No. 01 Old River				Right	1.15	03/17/2009 03/17/2009	John Paasch

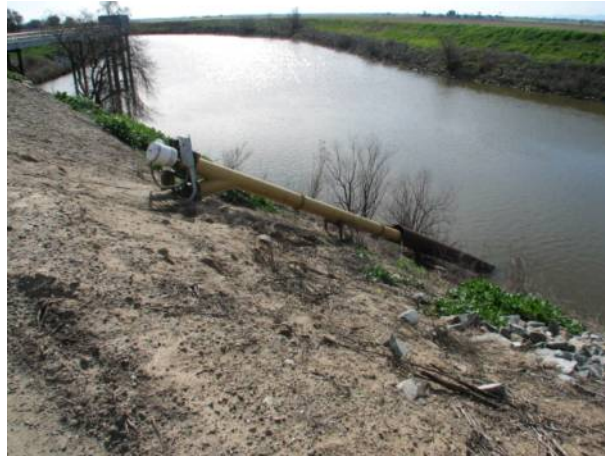
Levee Mile Report Line	1
Start Levee Mile	0.01
End Levee Mile	0.01
Location	Water Side
Category	Earthen Levee
Item	Encroachments

Irrigation intake off Old River.

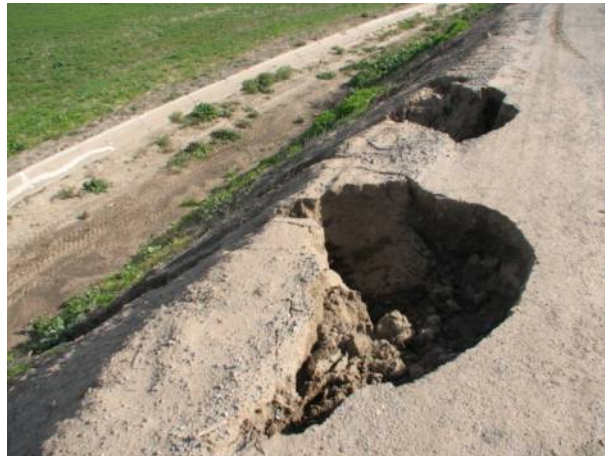
Levee Mile Report Line	2
Start Levee Mile	0.11
End Levee Mile	0.11
Location	Land Side
Category	Earthen Levee
Item	Erosion / Bank Caving

Two large erosion locations present on the landside hinge extending the entire slope length.

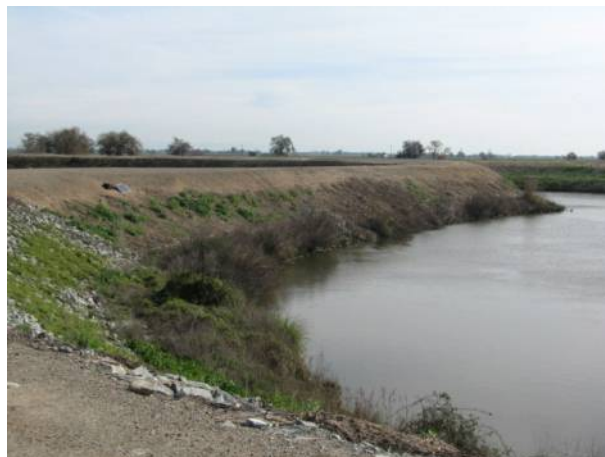
Levee Mile Report Line	6
Start Levee Mile	0.32
End Levee Mile	0.32
Location	Water Side
Category	Earthen Levee
Item	Encroachments

Monitoring equipment includes locked tool box, cable and solar panel.

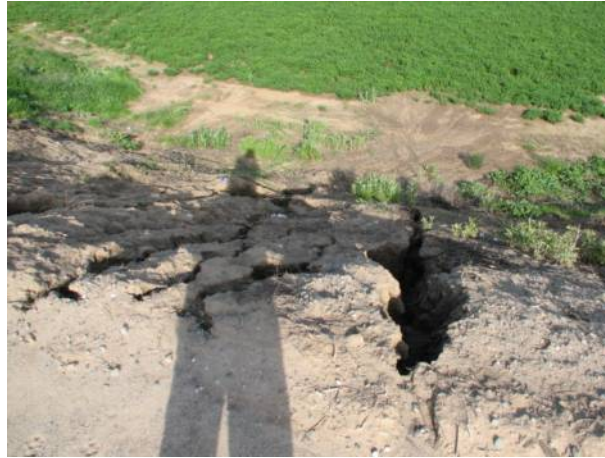
Levee Mile Report Line	10
Start Levee Mile	0.54
End Levee Mile	0.54
Location	Land Side
Category	Earthen Levee
Item	Erosion / Bank Caving

Erosion of landside slope present with sedimentation of material at toe.

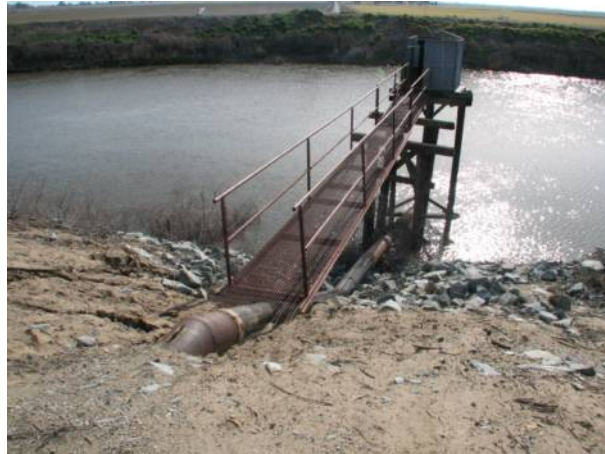
Levee Mile Report Line	11
Start Levee Mile	0.86
End Levee Mile	0.86
Location	Land Side
Category	Earthen Levee
Item	Encroachments

Irrigation pump and pipe on present waterside slope and through levee crown.
